Manhole Inspection Summary

Manhole # S31YY_003MH

Location Address: **200 CLERGIE DR**

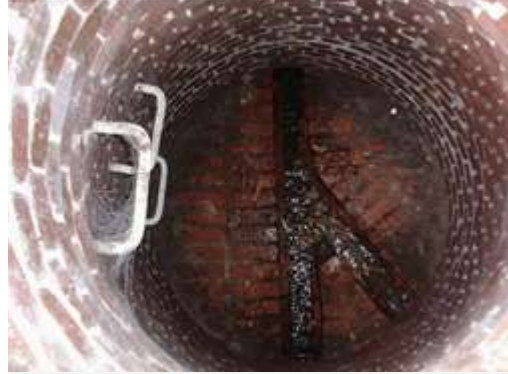
Top View

Evidence of surcharge - Bench debris.
Channel debris.

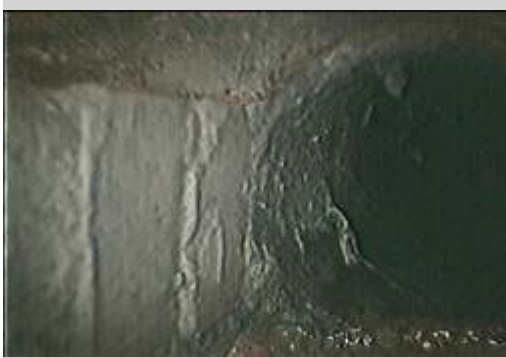
Defect

roots in the pipe

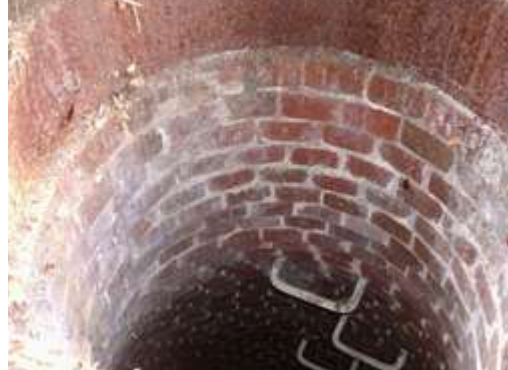
Defect

Infiltration: ☐ None ☒ **Joint** ☐ Cracks ☐ Mortar ☐ Roots ☐ Wall

Infiltration: ☐ None ☐ Joint ☐ Cracks ☐ Mortar ☐ Roots ☒ **Wall**

Adjustment and Barrel infiltration.

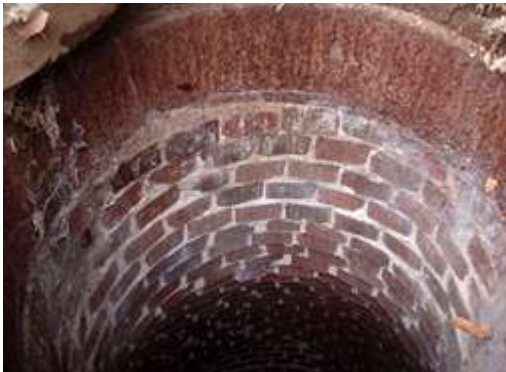
Defect

Adjustment infiltration.

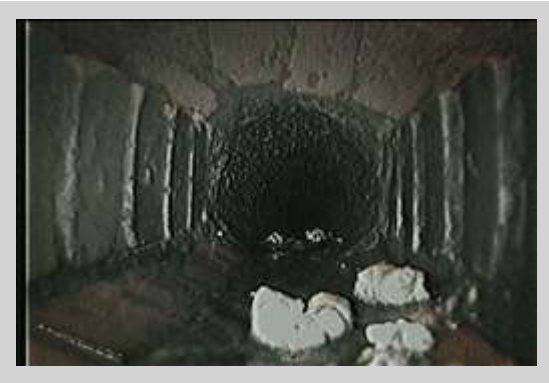
8 in. Circular Gravity Sewer Pipe Out @ 12 O'Clock

Channel deterioration.

Deposits: ☐ None ☒ **Mud** ☐ Sludge ☒ **Debris** ☐ Grease

Infiltration: **Evidence** Pipe Seal Cond: **Roots**

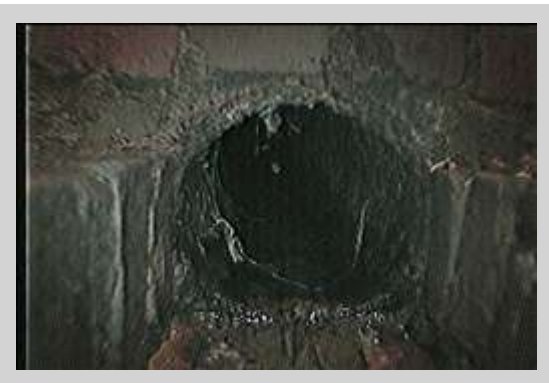
6 in. Circular Gravity Sewer Pipe In @ 5 O'Clock

Deposits: ☐ None ☒ **Mud** ☐ Sludge ☒ **Debris** ☐ Grease

Infiltration: **Evidence** Pipe Seal Cond: **Roots**

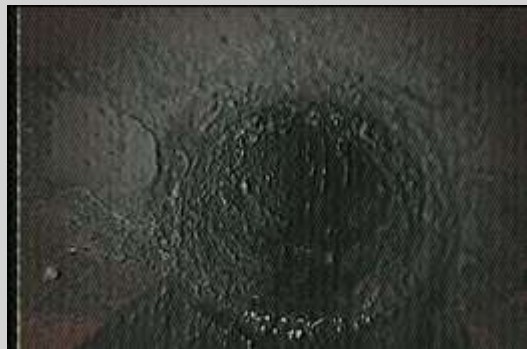
Pipe In @ 6 O'Clock

Deposits: ☐ None ☒ **Mud** ☐ Sludge ☒ **Debris** ☐ Grease

Infiltration: **Evidence**

Pipe Seal Cond: **Roots**
